Laboratory and Field Tests of a Wire Mesh Frazil Collector

Special Report 90-35

Prepared for OFFICE OF THE CHIEF OF ENGINEERS

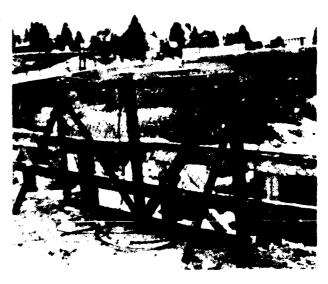
Figure 9. Chain link fence test structure with little frazil ice accumulation.

During the test period, nighttime low temperatures were -8 to 10°F and daytime highs were 18 to 32°F. Moderately high temperatures near the end of the test period, when the anti-climb fence and the welded concrete-reinforcing wire mesh were tested, did not allow us to obtain useful results because there was no frazil being generated. Also, because of the small size of the structure compared to the stream widtn, most of the suspended ice flowed around it. During the test period, there was a fairly large concentration of surface frazil (on the order of 30-50% of the surface area), but it accumulated only on the expanded sheet metal screen. Figure 8: hows the accumulation of ice on the expanded sheet metal. Although not clearly shown in the photograph, most of the screen was clogged. Figure 9 shows the chain link fence fabric with little accumulation.
